Devil's Slide/Hwy 1 Storm Repair

Daily Updates from Bijan Sartipi

Daily Update
July 19

Devil's Slide (post mile 39.14)

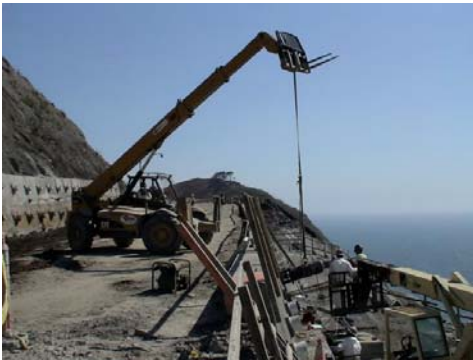
Stressing the last cable at level A

- All cable stressing is now complete.

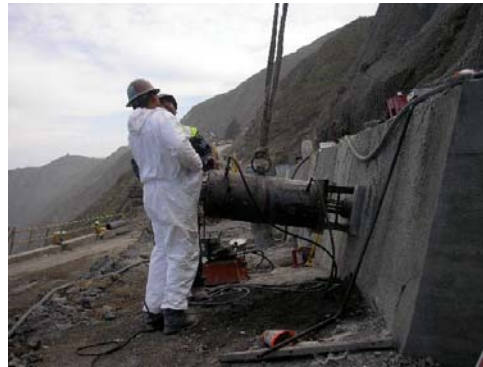
and the last at level D

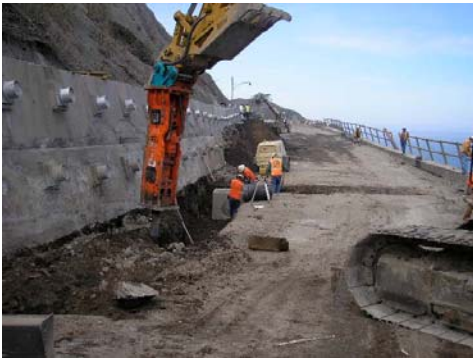
Excavating for the drain inlets

- The temporary bench is now completely removed allowing inlets for surface drains to be installed.

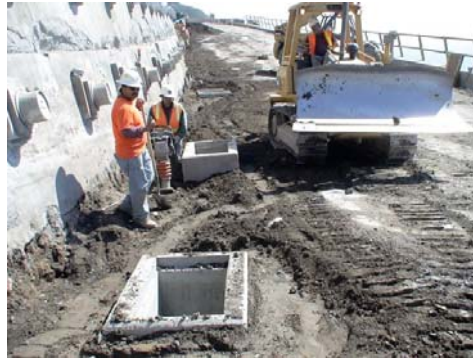
Installed drain inlets

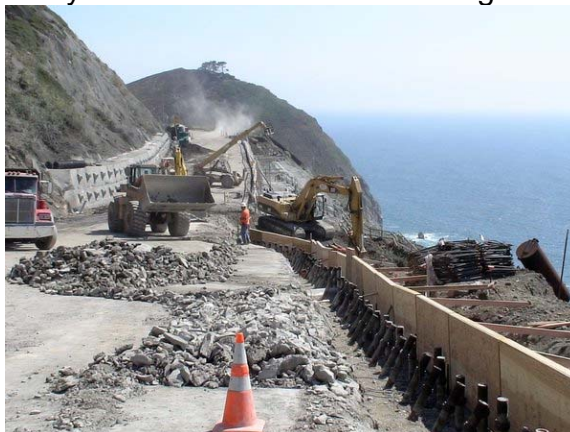
Overview of job site today

- Caltrans survey crews staked out the finish grade for the road surface.
